NBSIR 73-222 (R)

Investigation of the Skyline Plaza Collapse in Fairfax County, Virginia

E. V. Leyendecker and S. G. Fattal

Final Report

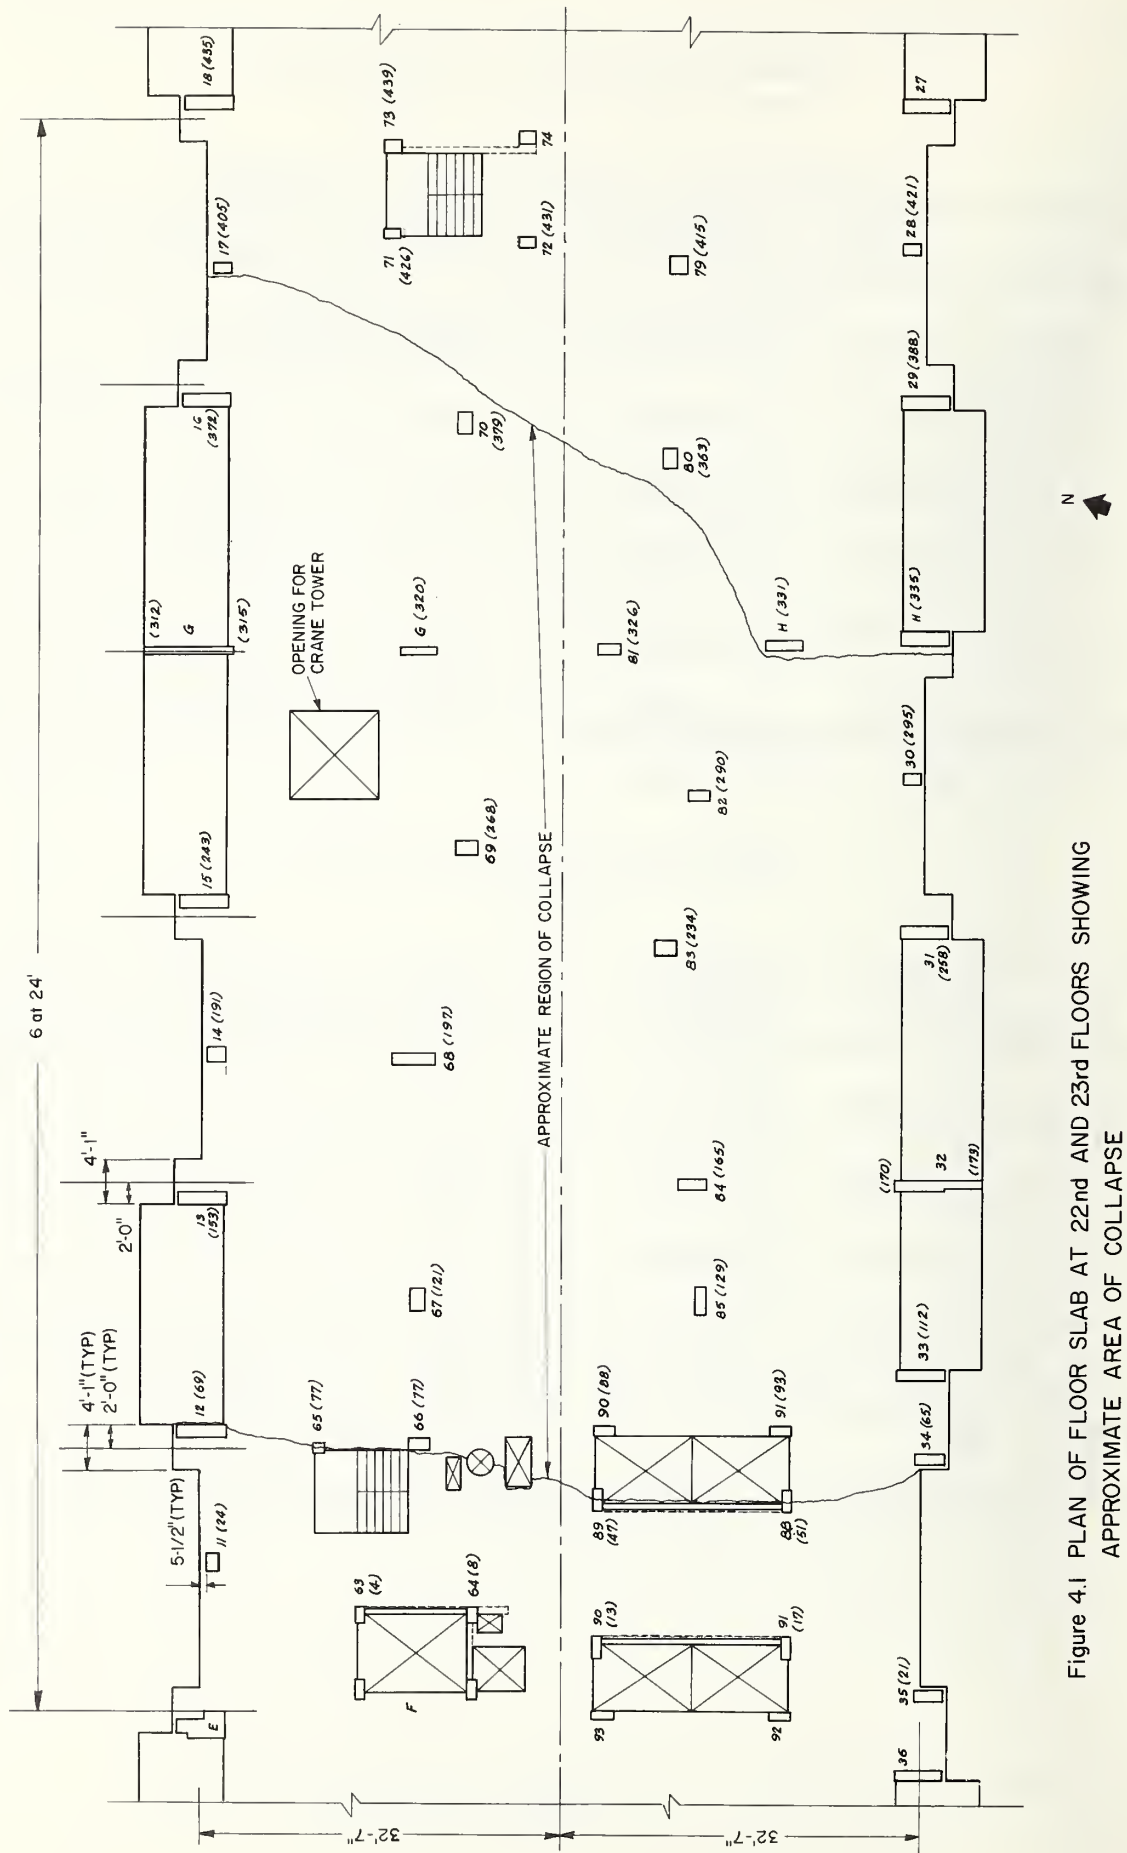
Figure 4.1 PLAN OF FLOOR SLAB AT 22nd AND 23rd FLOORS SHOWING APPROXIMATE AREA OF COLLAPSE

Three finite element analyses were made for the slab assembly in the region of collapse. The approximate area of collapse is shown in figure 4.1. All three analyses were based on the grid model shown in figure 4.2.

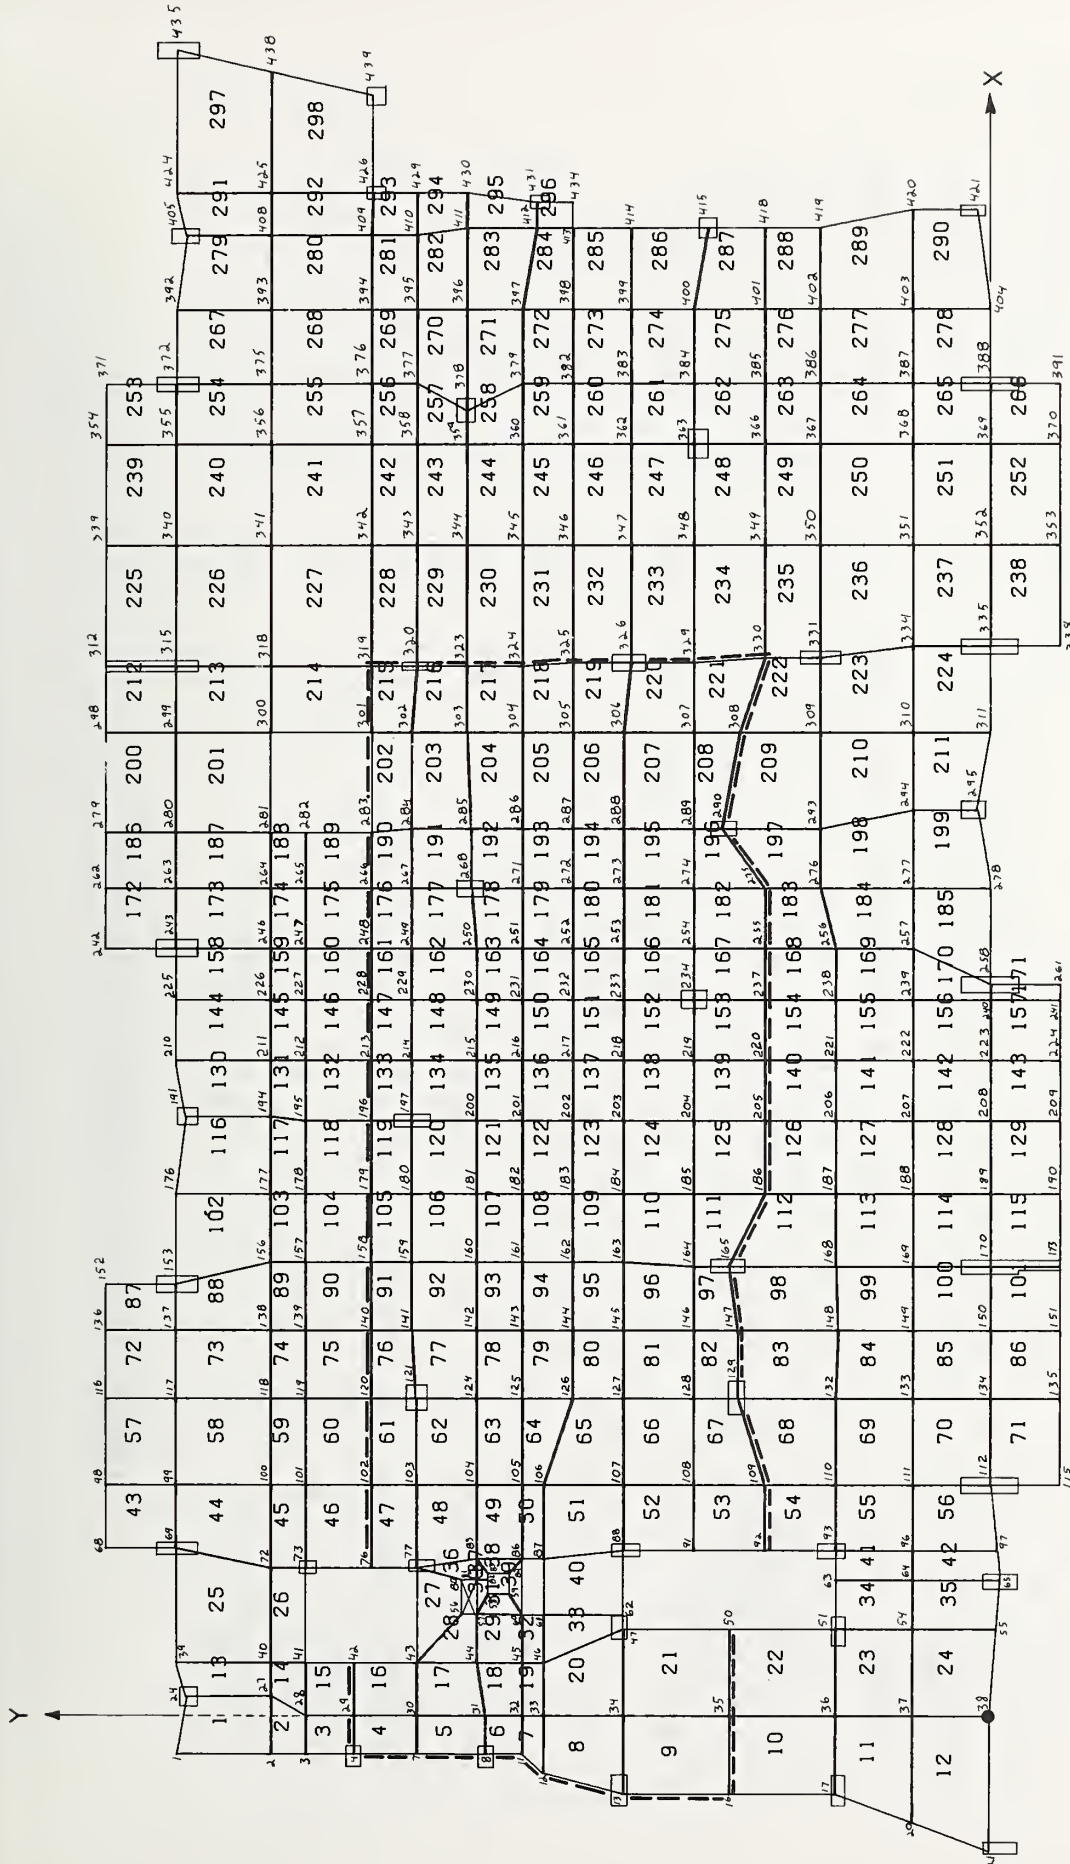
Figure 4.2 FINITE ELEMENT GRID FOR SLAB ANALYSIS

The grid layout in figure 4.2 is different from the slab in the contract drawings in certain aspects. The balcony slabs were assumed extending to the centerlines of the end columns. Likewise the boundary of the slab at north and south fascias between balconies was assumed extending to the centerlines of the flanking columns, eliminating, in effect, the stepped portion of the slab between a balcony and an adjacent fascia. Wherever possible, rectangular or square plate elements were used to construct the grid. In order to make column centroids coincident with nodal points of the grid a few trapezoidal plate elements were also introduced. By using a finer mesh one could develop a model which would more precisely represent the actual assembly. However, such a refinement is not justified because it would not significantly affect the results [7A].

the collapse (see section 2.2.2). A loading simulating the condition of partial removal of shoring was used. This Case is similar to Case 1 except the loads on the 23rd floor slab were reduced outside the region bounded by grid lines 7-320, 320-330, 330-16, and 16-7 as indicated in figure 4.2. To obtain these reduced loads, the loads from case 1 were multiplied by a factor which was based on the assumption that 22nd and 23rd floor slabs shared the loads on the 23rd floor in proportion to their respective elastic moduli. The modulus of elasticity of the 23rd floor slab was the same as was used in Case 1. The modulus of elasticity of the 22nd floor slab was calculated on the same basis as described in Case 1 using the average estimated concrete strength at the time of collapse of 1340 psi for the 22nd floor slab (see section 3.1.4).

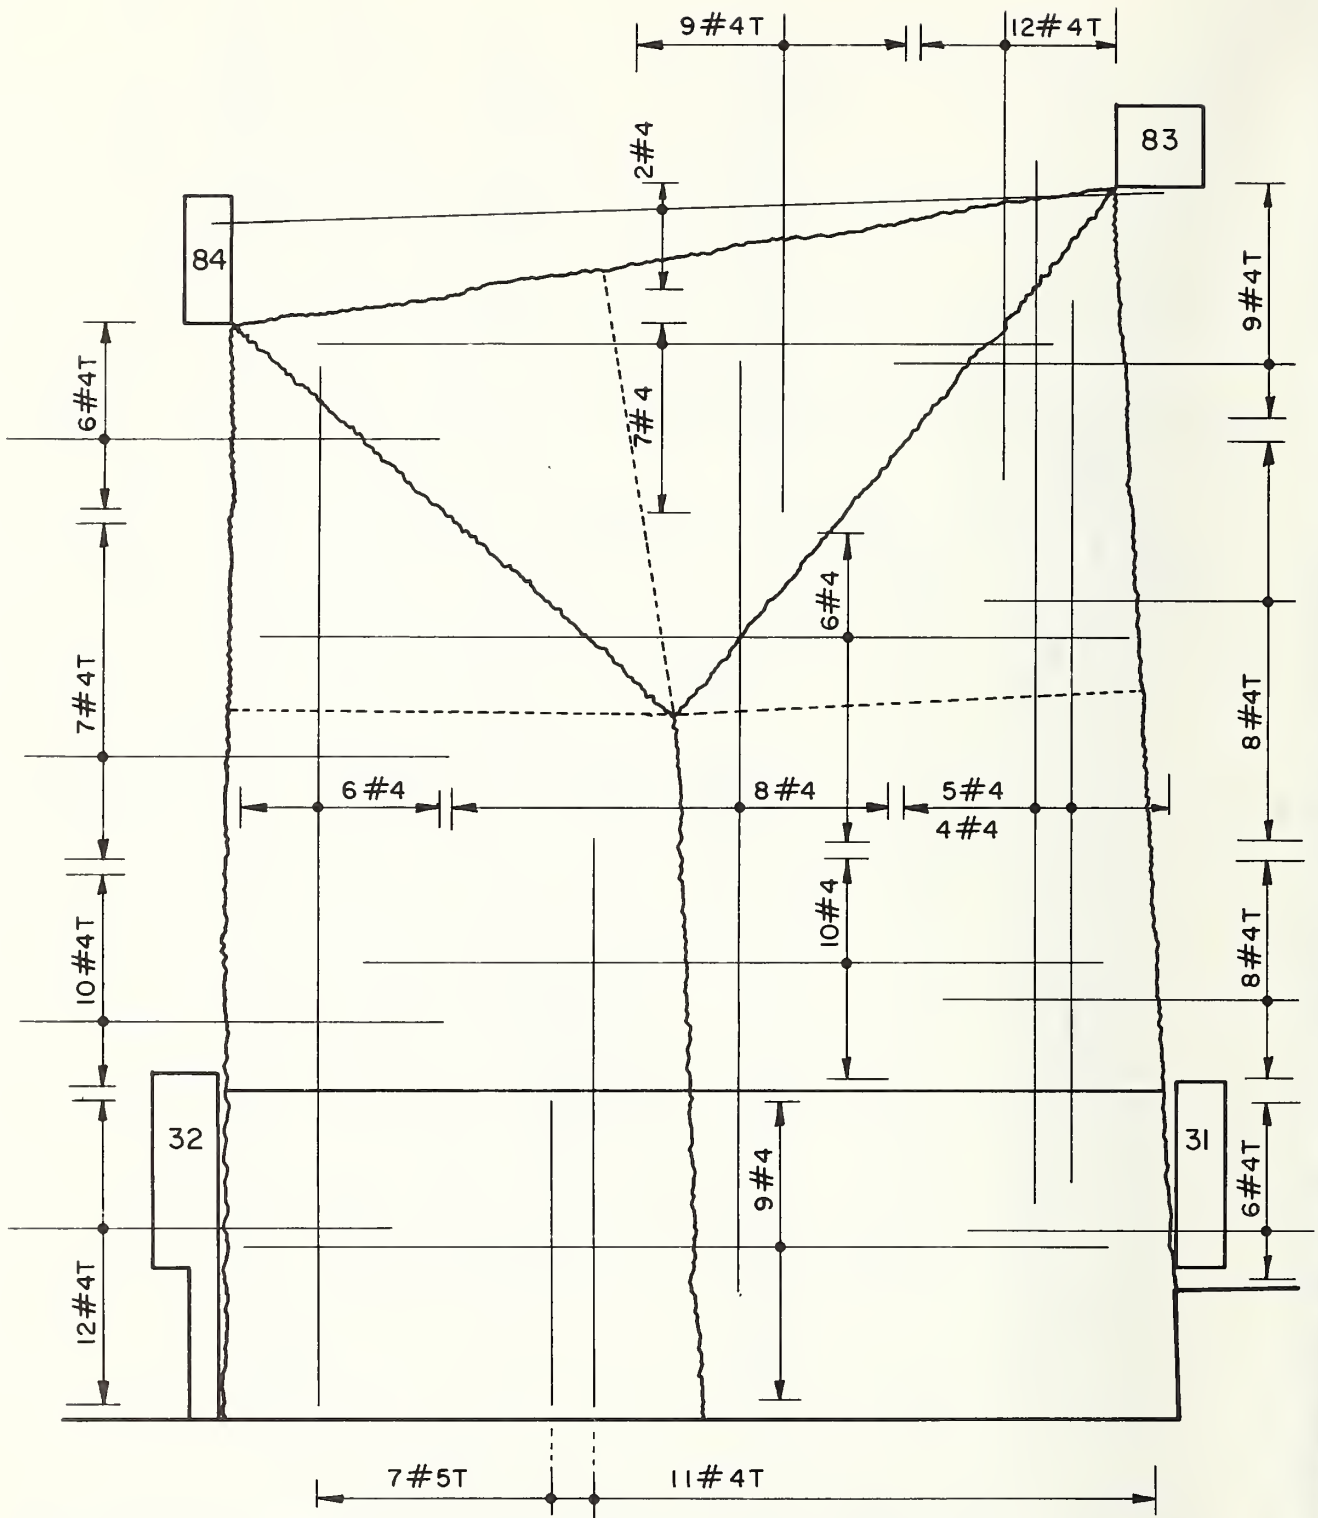
Figure 4.11 YIELDLINE PATTERN IN BALCONY PANEL

To further check the ultimate flexural capacity of the floor slab a selected critical area was investigated using yield line analysis. The yield line pattern assumed for the balcony panel bounded by columns 32, 84, 83 and 31 is shown in figure 4.11. Top and bottom reinforcement taken from the contract documents is indicated in the same figure. This particular analysis gave an ultimate load capacity of about 300 pounds per square foot indicating 80 percent excess capacity over construction loads. Other yield line analyses performed at selected interior panels gave consistently similar results. It should be noted that unless the assumed yield line pattern happens to be the same as would actually develop in the slab, the approach used will overestimate the slab capacity. However, the margin of approximation involved would be much less than the excess capacity indicated by these analyses.

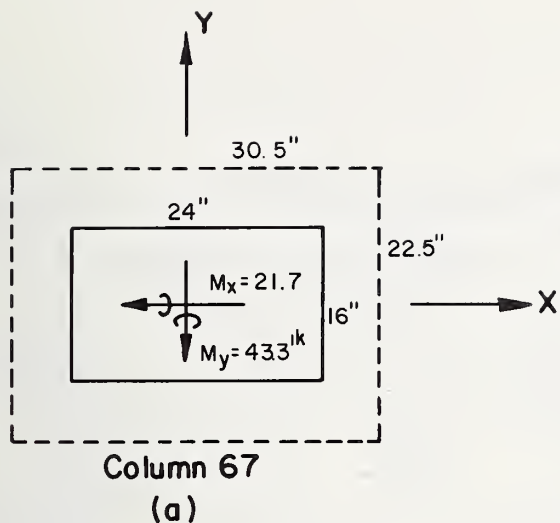
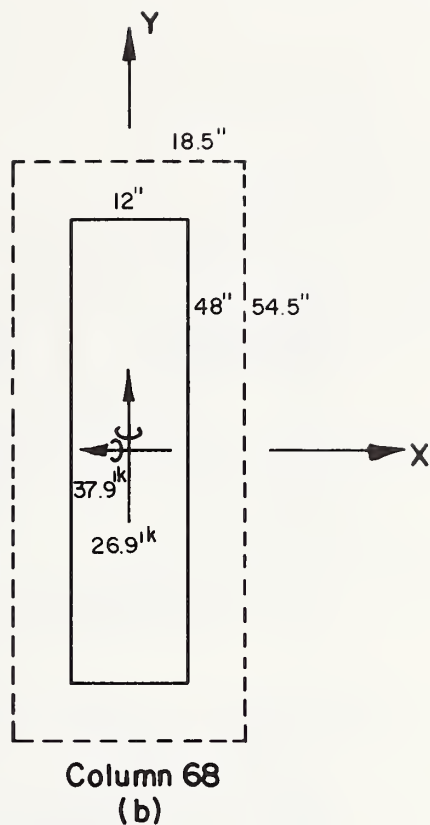
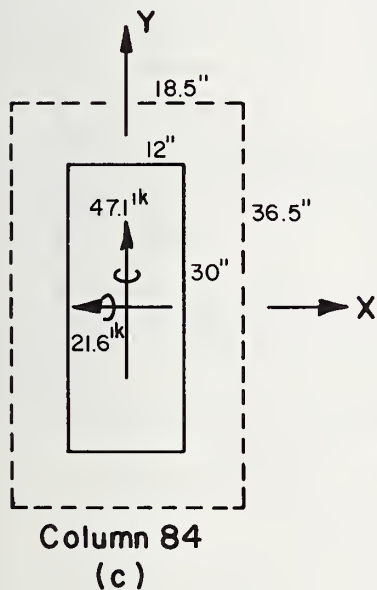
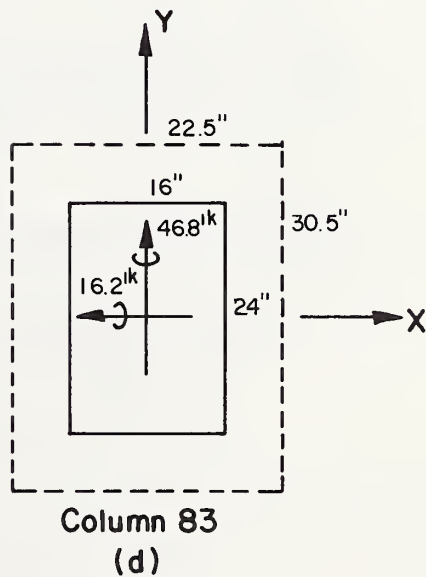
Figure 4.12 CRITICAL SECTION FOR SHEAR IN THE SLAB AROUND COLUMNS 67, 68, 83, 84

From the analytical results, axial loads and moments transmitted to column elements from the floor system were assessed in relation to peripheral column dimensions in order to establish which of the columns would be expected to create a severe shear condition in the slab. Figure 4.12 shows the four most critical regions identified at columns 67, 68, 83 and 84.

Figure 4.13 tabulates the results of the analysis of shear stresses in the 23rd-story floor slab for cases 1 through 3, based on the critical sections shown in figure 4.12.

Column No.	Case	v_{\max} psi	$f'_c \frac{1}{}$ required psi	f'_c estimated psi
67 (16 x 24)	1	147	1870	960-1440
	2	147	1870	3000
	3	128	1417	960-1440
68 (48 x 12)	1	113	1104 (1724)	960-1440
	2	113	1104 (1724)	3000
	3	116	1164 (1816)	960-1440
83 (24 x 16)	1	148	1894	960-1440
	2	148	1894	3000
	3	130	1462	960-1440
84 (30 x 12)	1	149	1920	960-1440
	2	149	1920	3000
	3	145	1819	960-1440
